Maxey Flats, Kentucky, Disposal Site

This fact sheet provides information about the Maxey Flats, Kentucky, Disposal Site.

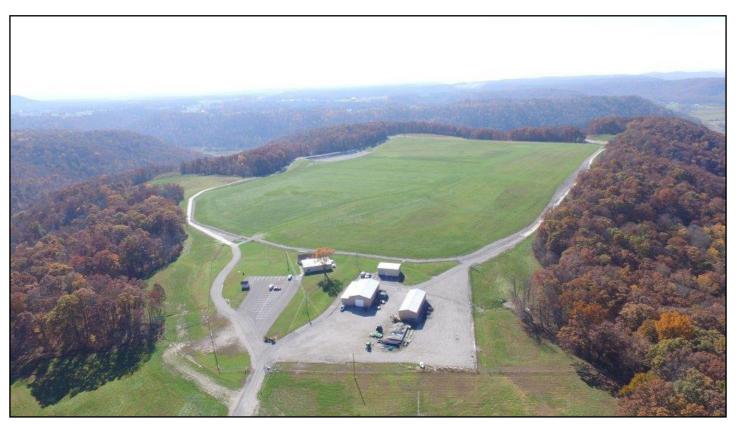
2017 Aerial View of the Maxey Flats Disposal Site; Substantial Completion of the Final Cap Was Achieved in November 2016

The end of the interim maintenance period and the beginning of the final closure period is defined in the ROD as the time when subsidence of the trenches has nearly ceased and final cap installation can begin. EPA is required to determine the acceptable subsidence criteria, in consultation with the commonwealth. The commonwealth has presented EPA with subsidence data verifying that the trench stabilization criteria have been achieved. After evaluating the data, EPA agreed with the criteria and approved the commonwealth's request to proceed to the final closure period beginning September 2013. Final closure included construction of a permanent earthen cap consisting of layers of plastic covered with soil and vegetation. Substantial completion of the final cap was achieved in November 2016.
